Evaluating Roadway Subsurface Drainage Practices

Final Report
May 2013

IOWA STATE UNIVERSITY
Institute for Transportation

Sponsored by
Iowa Highway Research Board
(IHRB Project TR-643)
Iowa Department of Transportation
(InTrans Project 12-428)

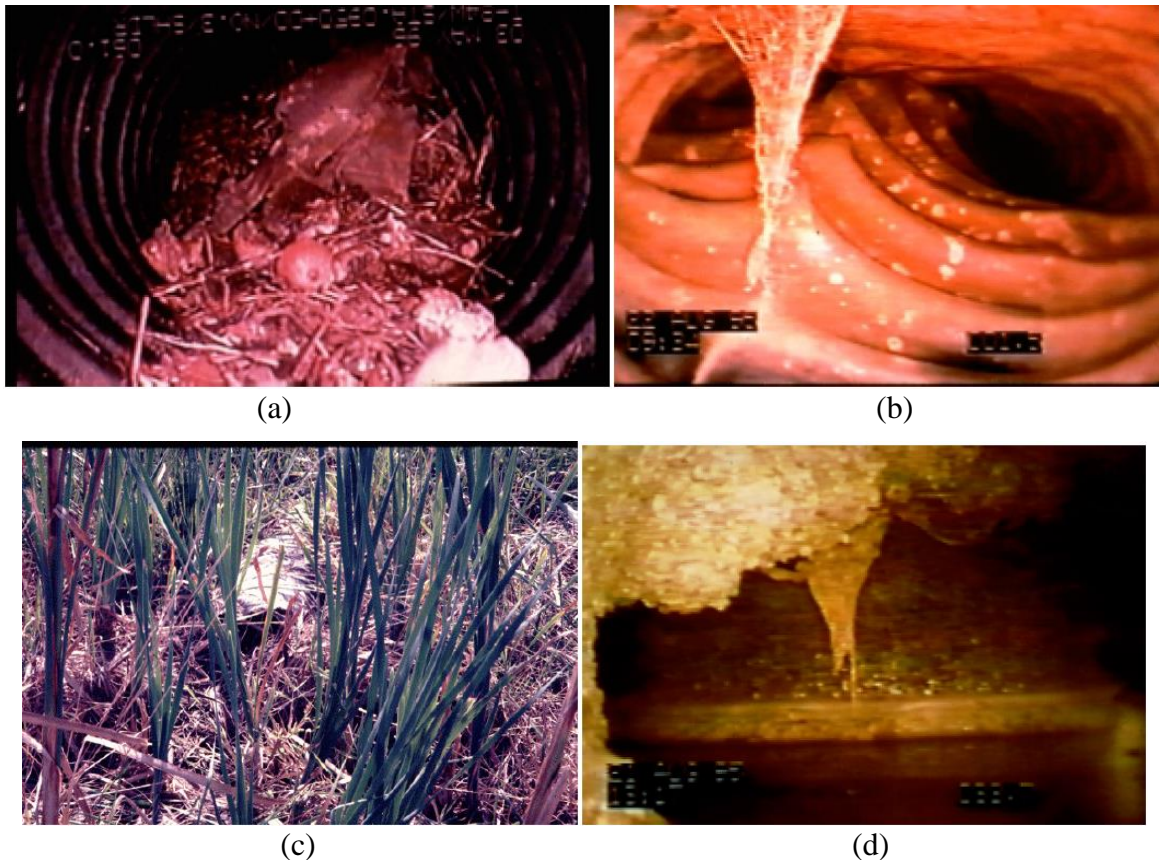
Figure 8. Common subsurface drainage system maintenance problems encountered by SHAs: (a) rodent nest, (b) crushed pipes during construction, (c) hidden outlet pipe, and (d) ninety-degree tee (Baumgardner 2002)

Baumgardner (2002) presented several visual examples and case histories to document FHWA attempts at stressing the importance of maintenance of pavement subsurface drainage maintenance to SHAs. Some common maintenance problems encountered by SHAs are shown in Figure 8.

According to Baumgardner (2002), the use of headwalls, reference markers, signs on fences, reflector disks in the shoulder, or painted arrows on the shoulder help SHAs greatly in providing maintenance. Even a simple arrow painted on the edge of the shoulder serves as a good reference marker for maintenance personnel. The FHWA also recommends the use of larger headwalls given that it has the following advantages: easier for maintenance personnel to locate the drainage outlet pipe, roadside vegetation is located away from the outlet, reduces erosion at the pipe outlet, and prevents crushing of the outlet pipe during construction and mowing operations (Baumgardner 2002). In summary, Baumgardner's synthesis study concluded that an SHA should not use permeable bases if it is unwilling to make a maintenance commitment because it will increase the rate of pavement damage.

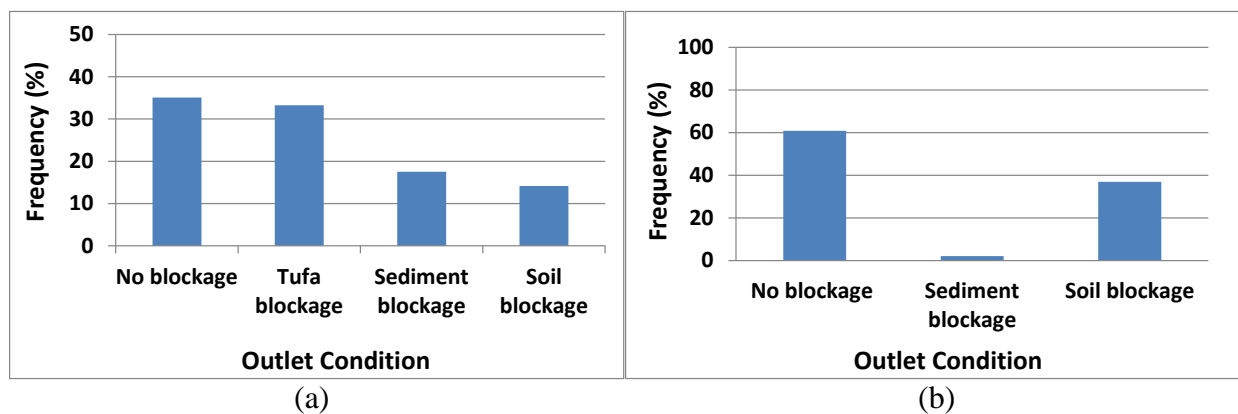
Figure 19. Distribution of Iowa roadway subsurface drainage outlet condition categories: (a) JPCP and (b) HMA

Figure 19 presents the distributions of these four drainage outlet conditions observed in JPCPs and HMA pavements. About 35 percent of the outlets in JPCPs and 60 percent of outlets in HMA pavements were not blocked by any materials. About 35 percent of outlets in JPCPs were blocked by tufa, about 17 percent were blocked by sediment, and about 14 percent were blocked by soil deposits. However, most of the blocked outlets in HMA pavements were blocked by soil deposits (see Figure 19b). Only 2 percent of outlets in HMA pavements were blocked by sediment.

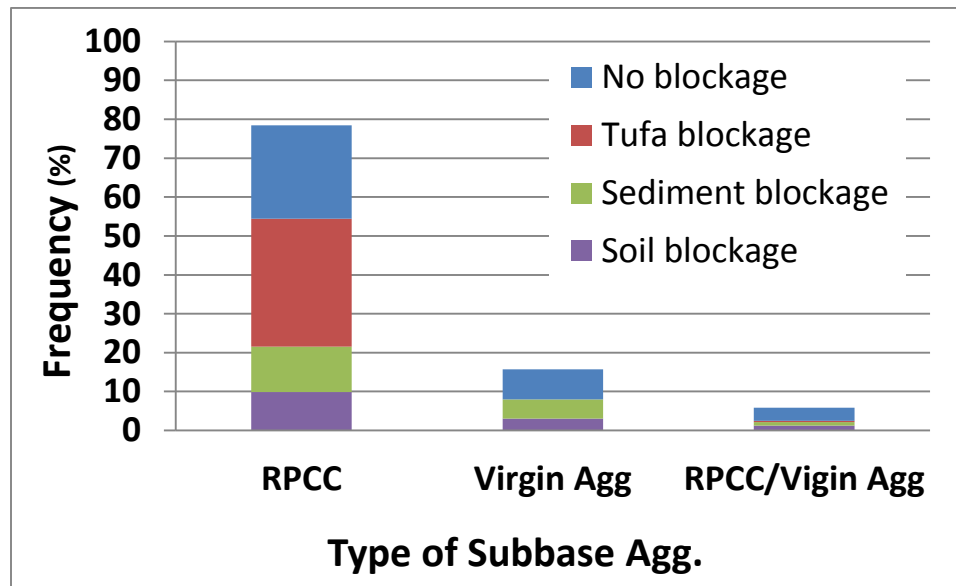
Figure 20. Subsurface drainage outlet conditions distribution with respect to Iowa JPCP subbase aggregate type

Figure 20 presents distributions of drainage outlet conditions with respect to JPCP subbase aggregate material types. As seen in this figure, tufa formation and drain outlet blockage were observed mainly in JPCP with RPCC subbase materials. Few drain outlets with tufa blockage were observed in JPCP with blended RPCC and virgin aggregate subbase materials (10 spots on US 151/S/MP 67.57 to MP 67.57 and 9 spots on US 151/N/MP 62.55 to MP 67.48).

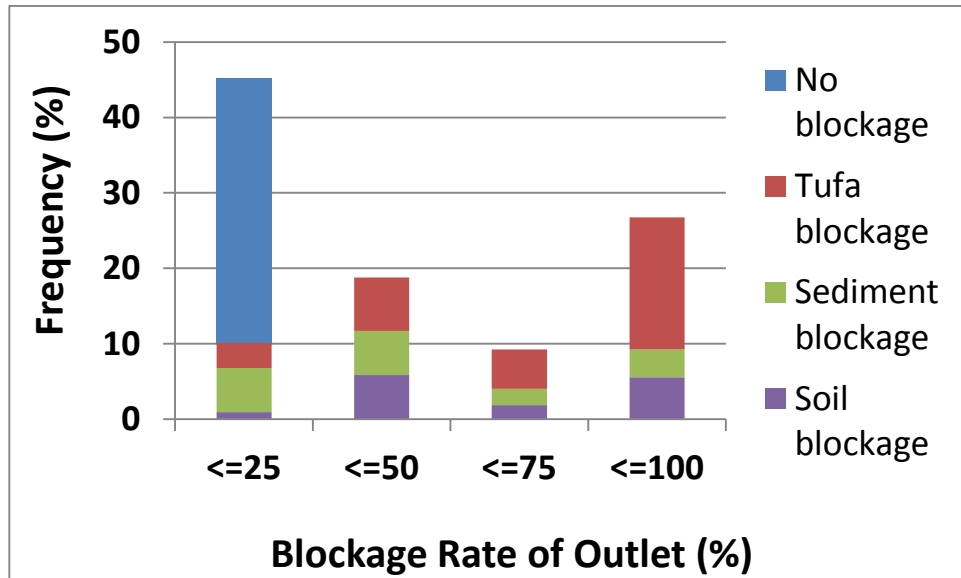
Figure 21. Blockage rate and type of Iowa JPCP subsurface drainage outlets

Figure 21 and Figure 22 present blockage rates of drainage outlet conditions in JPCPs and HMA pavements, respectively. As seen in Figure 21, at higher blockage rates, JPCP drain outlets are blocked primarily by tufa rather than soil and sediment. However, irrespective of the blockage rate, the HMA pavement subdrainage outlets are blocked primarily by soil.

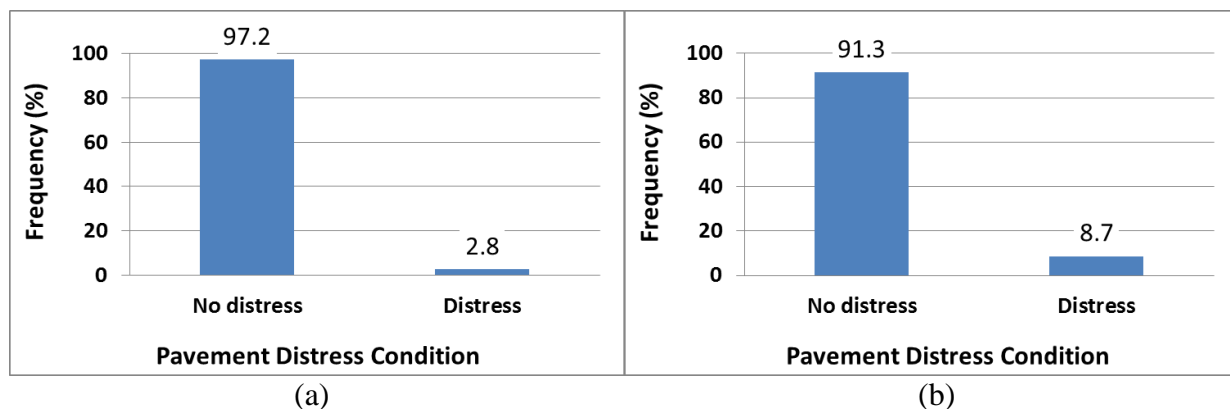
Figure 26. Distress condition in investigated Iowa pavements: (a) JPCP and (b) HMA

Figure 26 presents distributions of pavement surface distress observed on Iowa JPCPs and HMA pavements. More than 90 percent of investigated spots do not have any surface distress on both pavement types. The distress types observed in JPCP are transverse cracking, longitudinal cracking, and corner cracking. The only relevant distress observed for HMA pavement is transverse cracking.

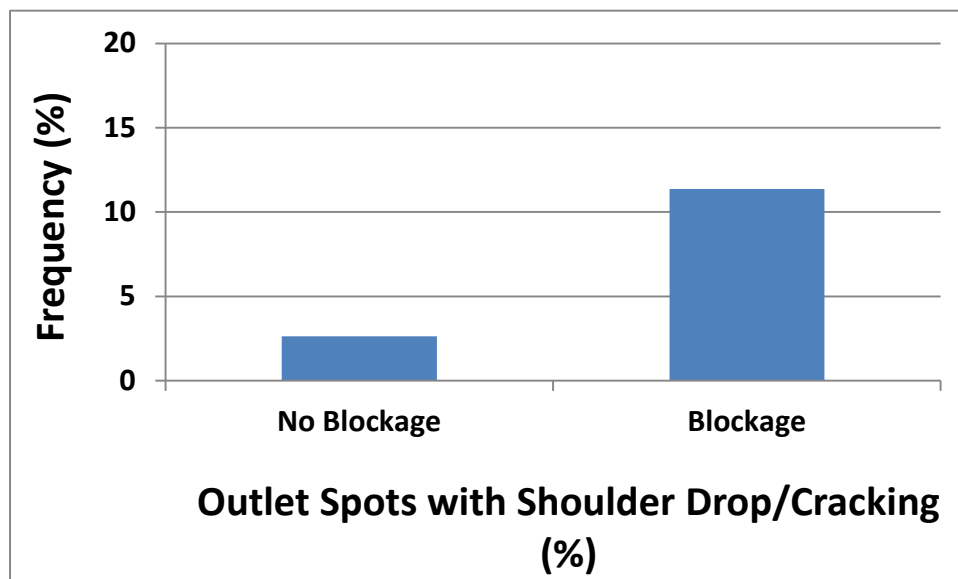
Figure 31. Outlet spots with shoulder drop/cracking in Iowa JPCP

Rather than surface distresses, more shoulder distresses (shoulder drop or cracking) as shown in Figure 30 were observed near blocked drainage outlet spots. Note that the opened outlet captured in Figure 30 was newly installed to replace the 100 percent blocked outlet. Figure 31 compares frequency of outlet spots with observed shoulder distress under opened and blocked outlet conditions. More than 10 percent of the blocked drainage outlet spots have shoulder distresses while only 2 percent among opened drainage outlets have shoulder distresses.

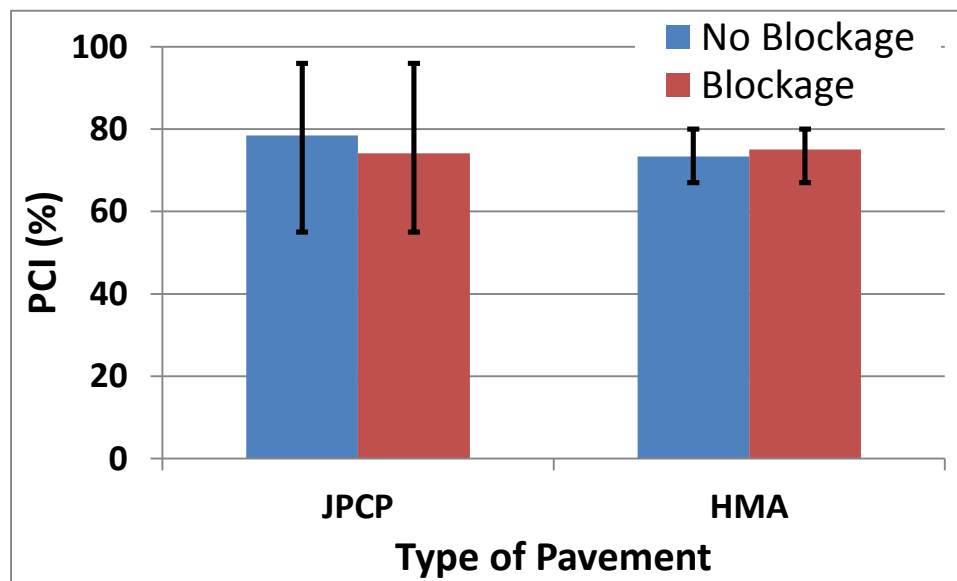
Figure 32. PCI distribution for investigated Iowa pavements with respect to drainage outlet condition

The PCI from the Iowa DOT PMIS was utilized as a performance indicator of the pavement's structural integrity and pavement surface condition. The PCI is a numerical index ranging from 0 for a failed pavement to 100 for a pavement in perfect condition. Figure 32 compares PCI of pavements at the opened drainage outlet spots and at the blocked drainage outlet spots for both JPCP and HMA pavement types.

Opened drainage outlet spots in JPCP show a little better performance than blocked drainage outlet spots while both outlet conditions have almost similar influences on HMA performance. However, these comparisons could not explain whether drainage outlet condition can affect pavement performance given that both opened and blocked drainage outlet spots have different traffic, pavement age, and pavement structure, which can all contribute to pavement performance.
